Design Guide

for Improving School Safety
in Earthquakes, Floods, and High Winds

6 Making Schools Safe From High Winds

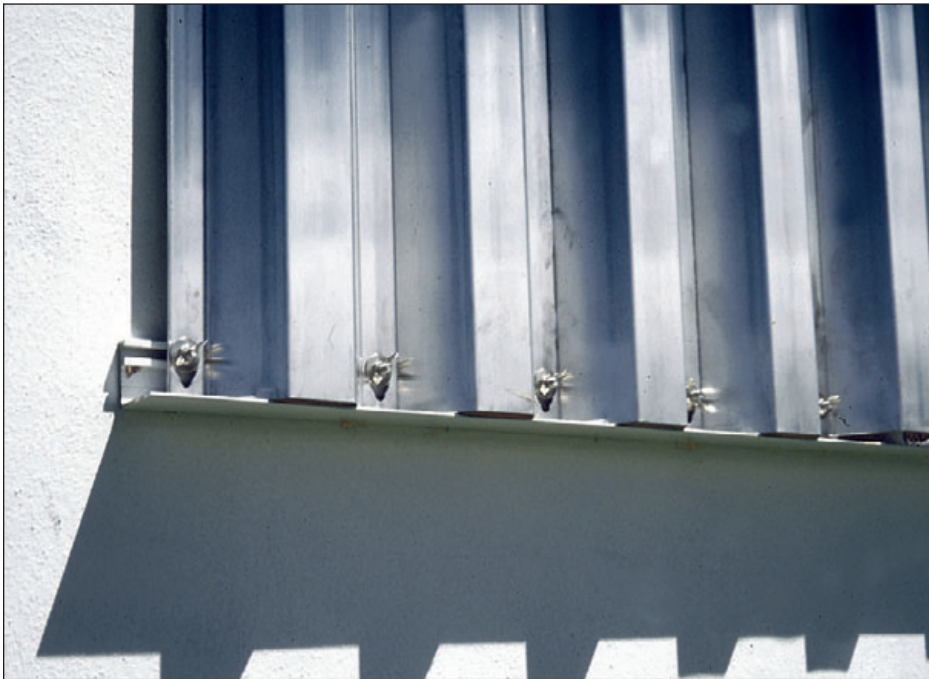
Figure 6-126:
A metal panel shutter.
Hurricane Georges
(Puerto Rico, 1998)

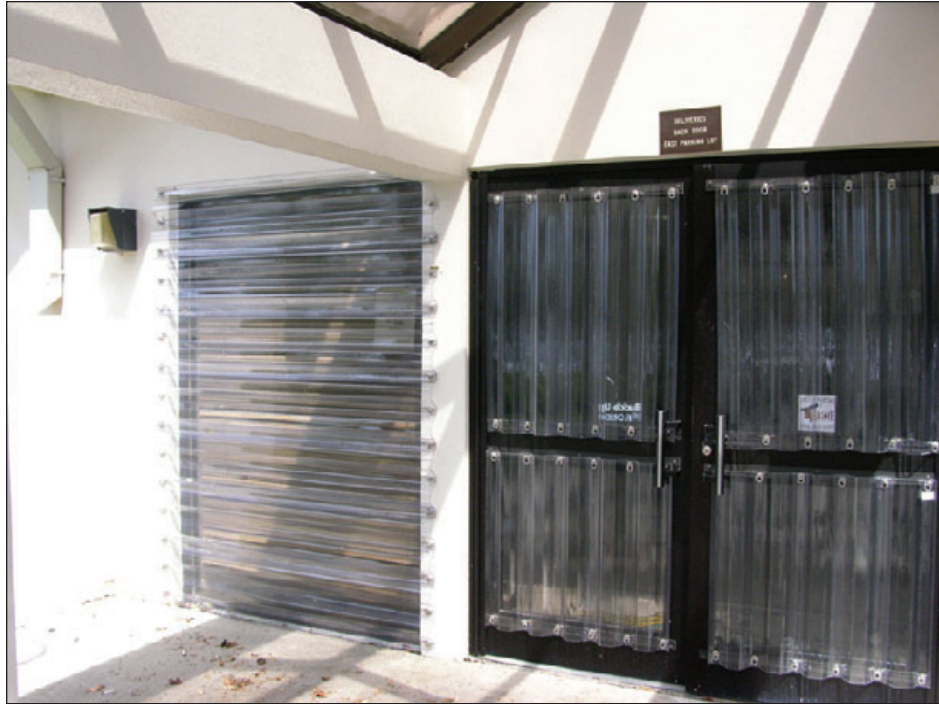
Figure 6-127:
Polycarbonate shutters were temporary screwed to the doors and wall adjacent to the window opening. An advantage of polycarbonate is its translucence, which allows daylight to enter the building without removing the shutters. Hurricane Francis (Florida, 2004)

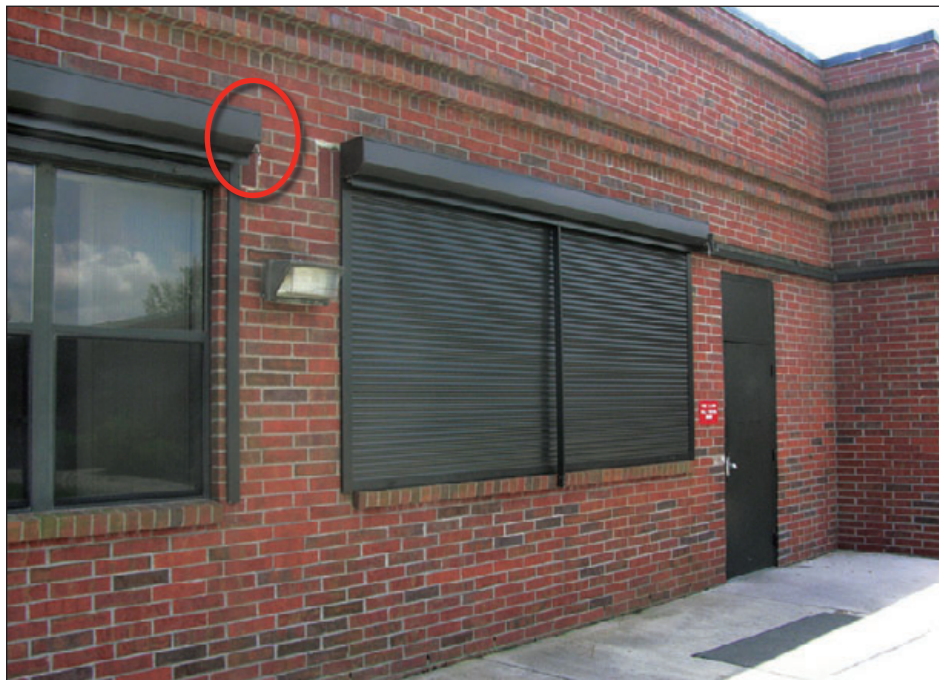
Figure 6-128:
This school has roll-down shutters. The toggle in the red circle allows the shutter to be manually raised. Estimated wind speed: 130–140 mph. Hurricane Charley (Florida, 2004)

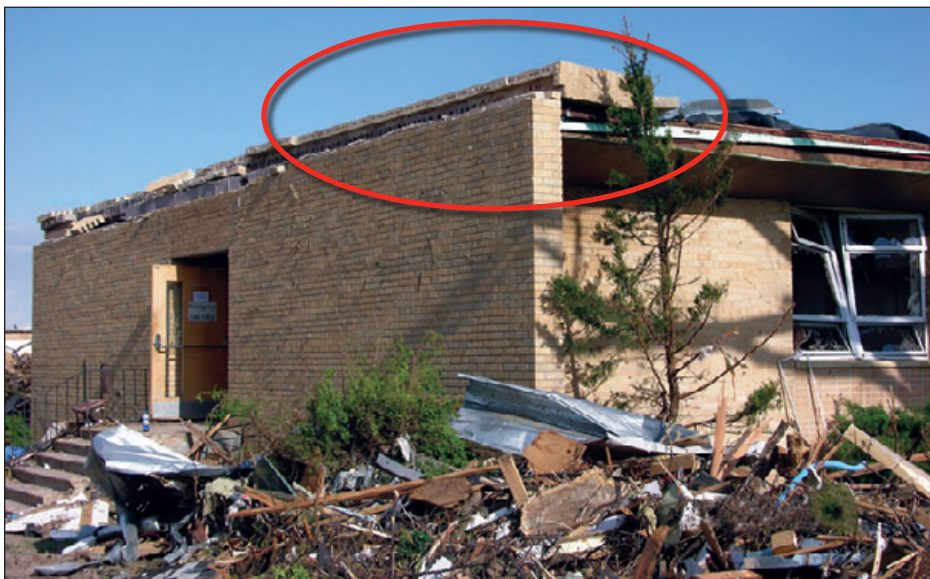
Figure 6-129:
Collapsed unreinforced
masonry parapet.
Greensburg Tornado
(Kansas, 2007)

If the parapet is constructed of masonry, it is recommended that its wind resistance be evaluated and strengthened if found to be inadequate. The masonry parapet shown in Figure 6-129 fell onto the roof. Had it fallen in the other direction, it would have blocked the entry and would have had the potential to cause injury.

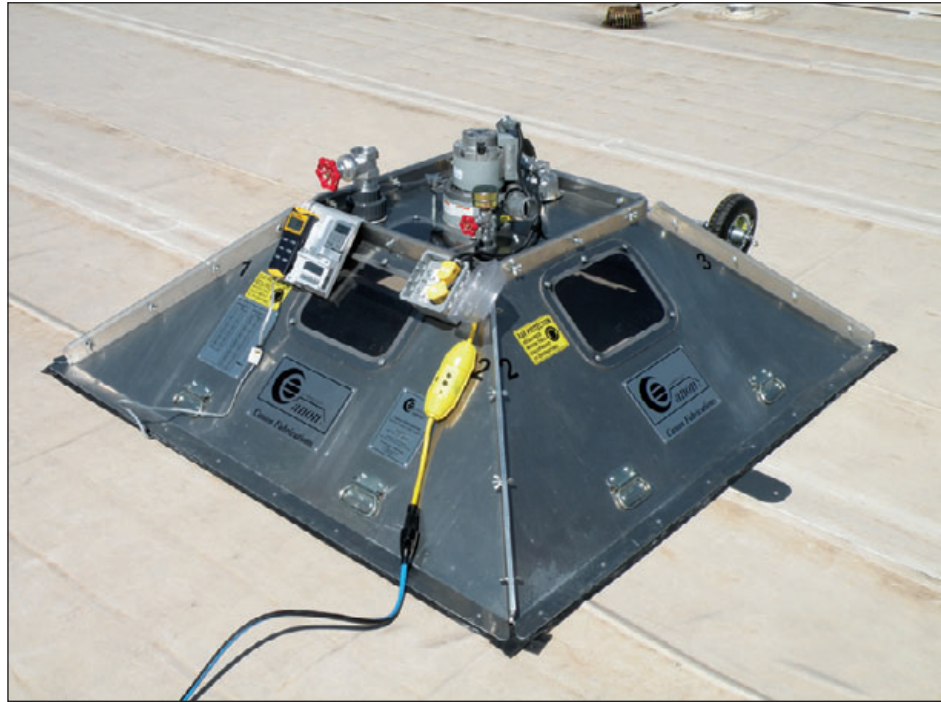
Figure 6-130:
View of a 5-foot by 5-foot negative pressure chamber used to evaluate roof system uplift resistance.

On-site testing in accordance with ASTM E 907 can be used to evaluate the uplift resistance of roof systems that have fully adhered membranes (see Figure 6-130). (Note: This test method is not capable of evaluating the uplift resistance of the roof deck.)

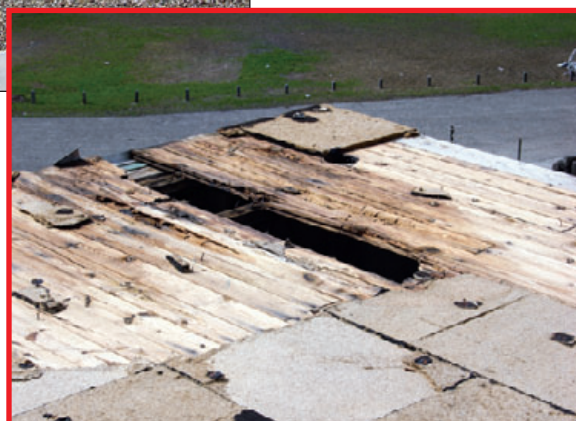
Figure 6-131:
The built-up roof on this school was blown off after a few of the rotted wood planks detached from the joists. Estimated wind speed: 120 mph. Hurricane Katrina (Mississippi, 2005)

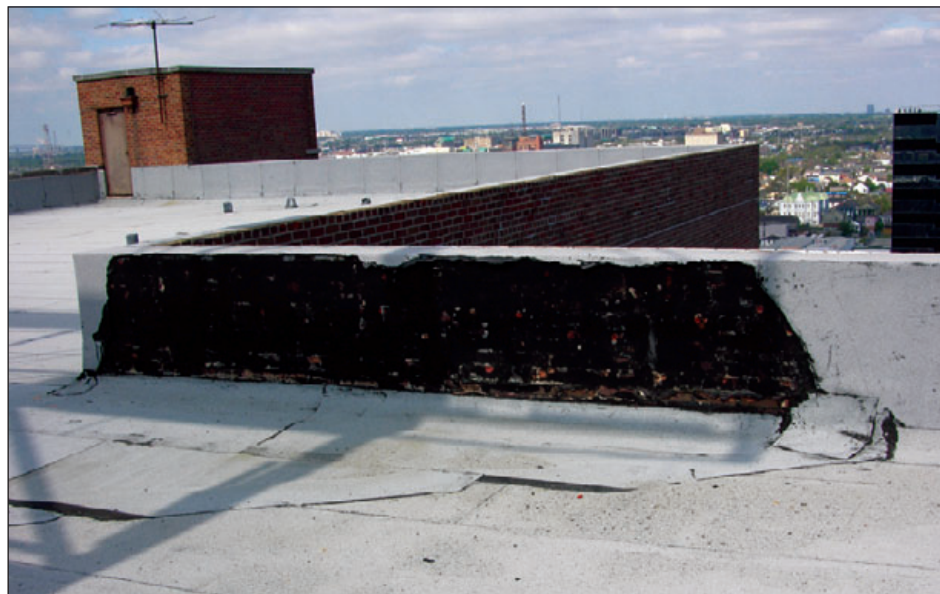
Figure 6-133:
Failed base flashing adhered directly to the brick parapet. Estimated wind speed: 105 mph. Hurricane Katrina (Louisiana, 2005)

If the roof has a parapet, it is recommended that the inside of the parapet be properly prepared to receive the new base flashing. In many instances, it is prudent to re-skin the parapet with sheathing to provide a suitable substrate. Base flashing should not be applied directly to brick parapets because they have irregular surfaces that inhibit good bonding of the base flashing to the brick (see Figure 6-133). Also, if moisture drives into the wall from the exterior side of the parapet with base flashing attached directly to brick, the base flashing can inhibit drying of the wall. Therefore, rather than totally sealing the parapet with membrane base flashing, the upper portion of the brick can be protected by metal panels (as shown in Figure 6-88), which permits drying of the brick.

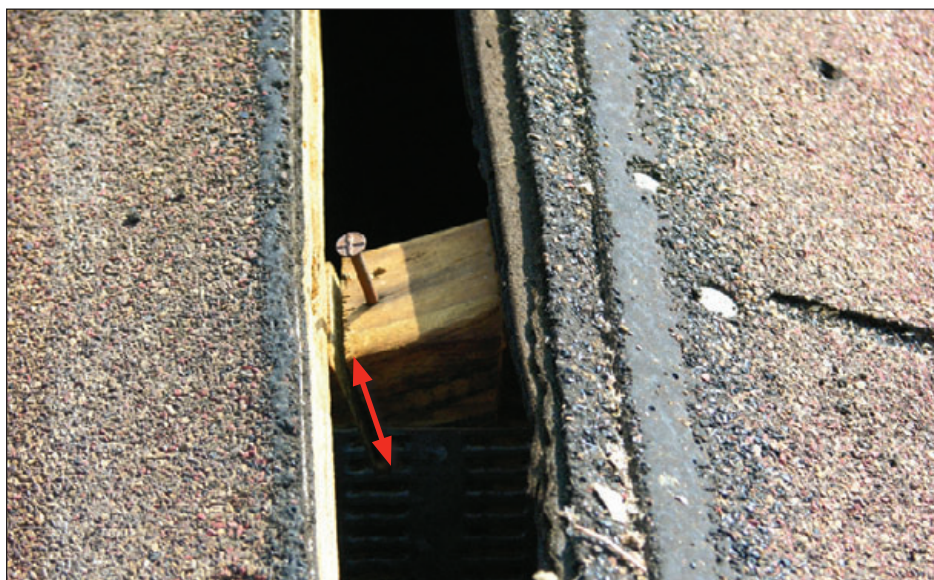
Figure 6-134: During a reroofing project a slot was cut in the plywood deck in order to allow air to flow from the attic to a new continuous ridge vent. The cutting depth of the saw was not adjusted for the thickness of the deck. The top 1½ inch of each truss and a portion of the metal nailing plate was inadvertently cut.

- If the decking is intended to act as a diaphragm and the diaphragm loads are high, the typical technique of cutting a slot through the decking (as shown in Figure 6-134) can compromise the integrity of the diaphragm by interrupting the transfer of diaphragm load from one side of the ridge to the other. For guidance on cutting vent openings that do not compromise diaphragm integrity, see Section 12.7.6 in FEMA 55. Note: An updated version of FEMA 55 is expected to be released in 2011.
- To prevent weakening of joists or trusses (as occurred at Figure 6-134), prior to slotting the deck, the depth of the saw should be adjusted so that the blade is only slightly below the bottom of the deck.

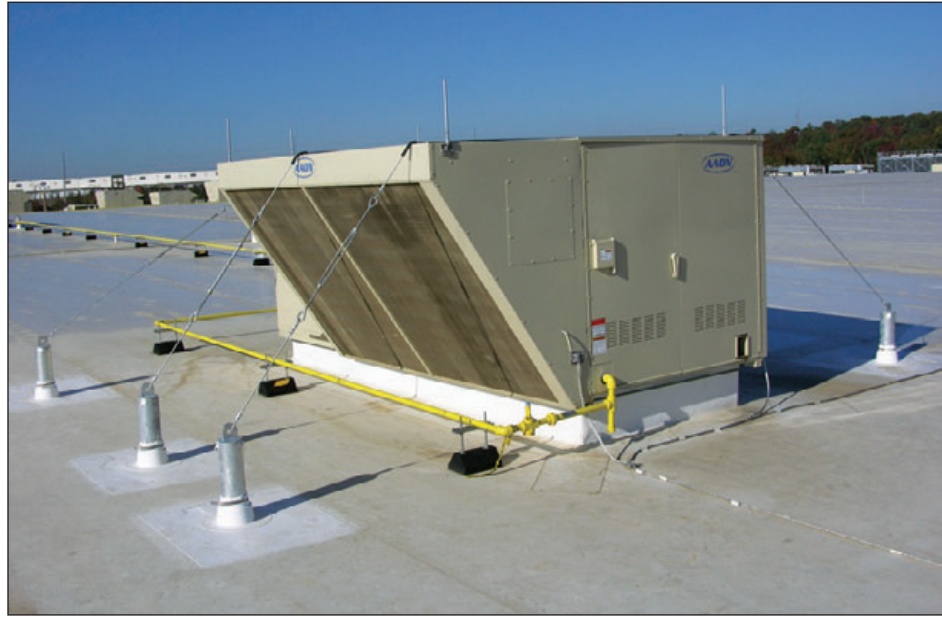
Figure 6-135:
To strengthen attachment of this HVAC unit, robust pipe anchors were attached to the deck and cables with turnbuckles installed.

Where HVAC units are inadequately anchored to their curbs, or where the curb is inadequately attached, cables with turnbuckles should be attached to pipe anchors attached to the deck (see Figure 6-135). The pipe anchors should be stiff so that the top of the anchor is not pulled towards the unit by the cable (otherwise, the unit may lift and shift off the curb).

If exhaust stacks such as those shown in Figure 6-137 are inadequately anchored, guys attached to pipe anchors such as those shown in Figure 6-135 should be installed. To avoid blow-off of rain caps as shown in Figure 6-137, additional straps or screws may need to be installed.

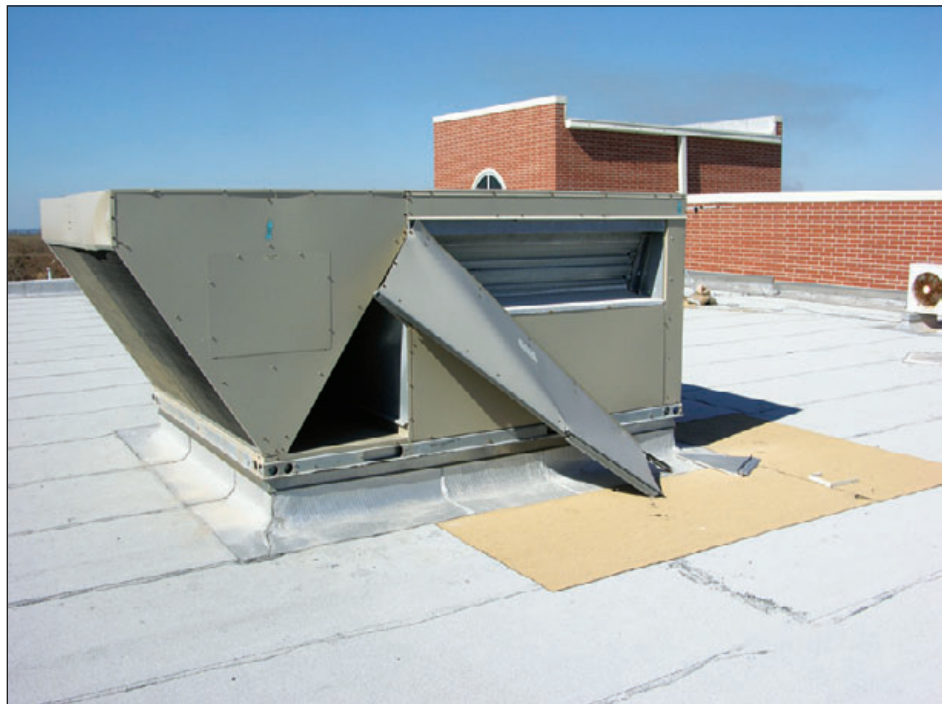
Figure 6-136:
At this school, the hood on this HVAC unit was inadequately attached. A strap between the hood and unit can be economically installed to avoid this problem. Estimated wind speed: 110 mph. Hurricane Ike (Texas, 2008)

If HVAC units have inadequately attached sheet metal hoods (see Figure 6-136), sheet metal straps can be economically installed between the top of the hood and the side of the unit. Equipment access panels may also need to be modified to resist wind loads as discussed in Section 6.3.4.1. Besides avoiding damage to the unit, these types of retrofits can prevent blown-off hoods and panels from causing injury and damaging the roof membrane or other building components.

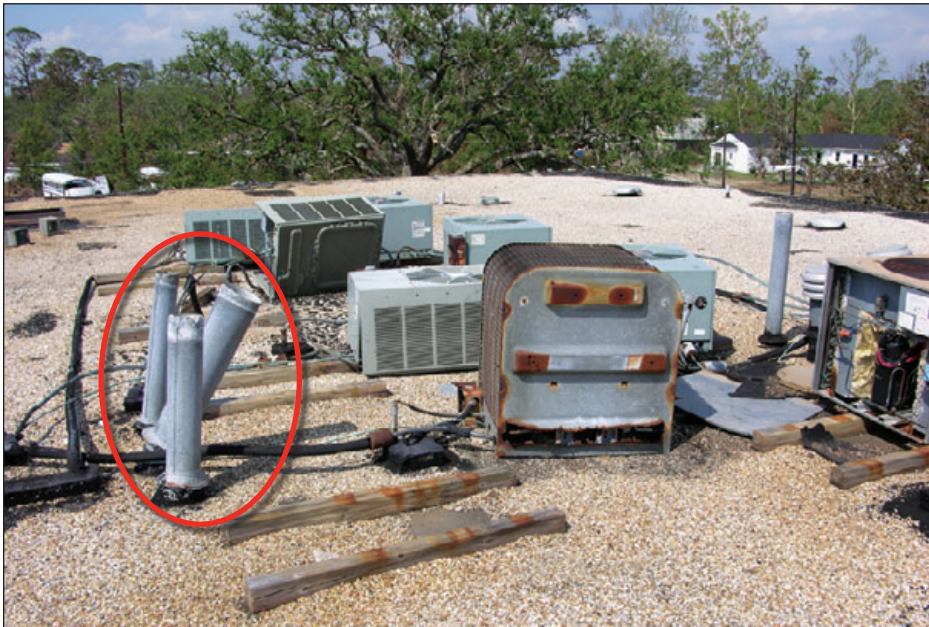
Figure 6-137: These condensers were simply mounted on wood sleepers that rested on the roof surface. Note the damaged exhaust stacks and missing rain caps (red oval). Estimated wind speed: 105 mph. Hurricane Katrina (Mississippi, 2005)

Where condensers are mounted to curbs that are adequately anchored to the deck, straps can be installed as shown in Figure 6-95 if the condenser attachment is inadequate. If condensers are mounted on sleepers (see Figure 6-137), then the condensers should be re-mounted and anchored to curbs or stands that are anchored to the roof deck.

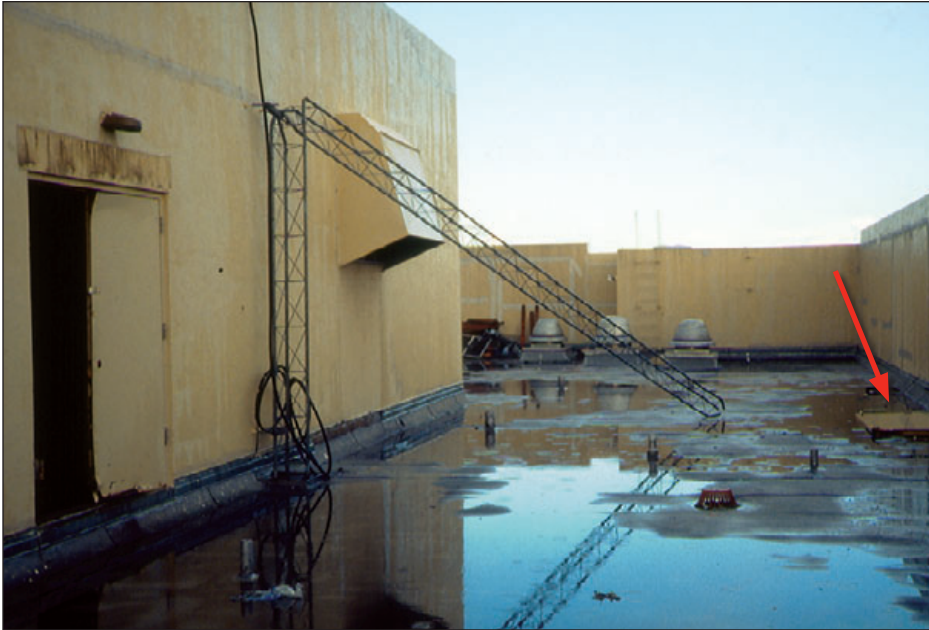
Figure 6-139:
The antenna collapsed and was whipped back and forth across the roof membrane. Hurricane Andrew (Florida, 1992)

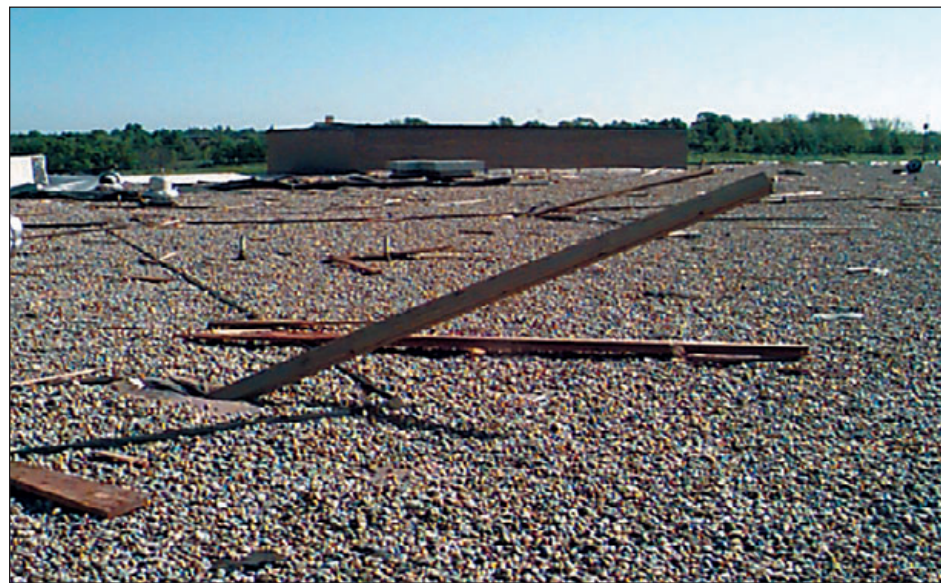
Figure 6-141:
A violent tornado
showered the roof with
missiles (Oklahoma,
1999)

Strong and violent tornadoes can generate very powerful missiles. Experience shows that large and heavy objects, including vehicles (see Figure 6-140), can be hurled into buildings at high speeds. The missile sticking out of the school roof in the foreground of Figure 6-141 is a double 2-inch by 6-inch wood member. The portion sticking out of the roof is 13 feet long. It penetrated a ballasted ethylene propylene diene monomer (EPDM) membrane, approximately 3 inches of polyisocyanurate roof insulation, and the steel roof deck. The missile lying on the roof just beyond is a 2-inch by 10-inch by 16-foot long wood member.

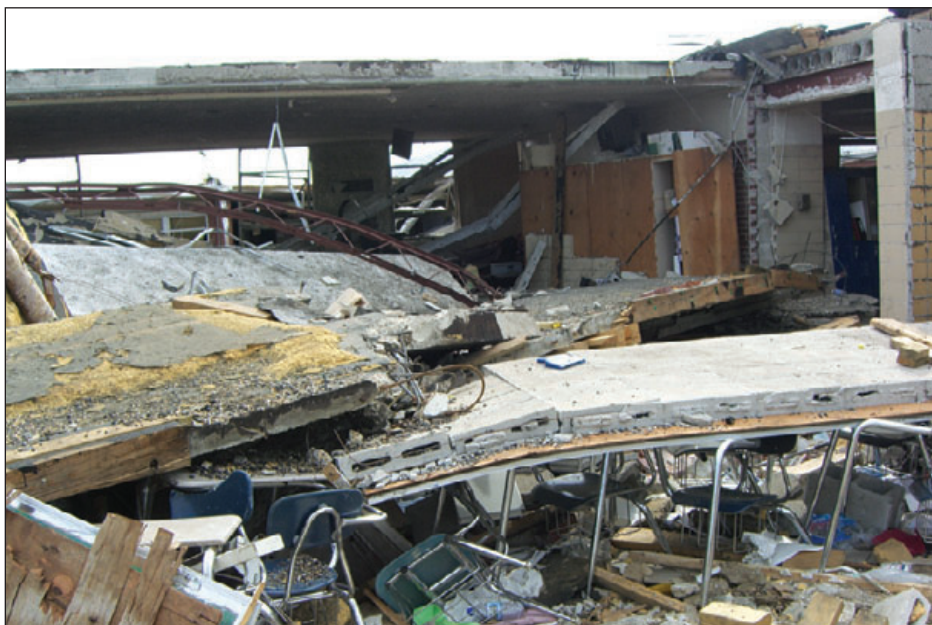
Figure 6-143 :
Unreinforced masonry walls and hollow-core concrete roof planks collapsed. Enterprise Tornado (Alabama, 2007)
